CALSPAN ON-SITE AMBULANCE CRASH INVESTIGATION
SCI CASE NO: CA11004

VEHICLE: 2007 CHEVROLET 3500 EXPRESS VAN
AMBULANCE BODY: WHEELED COACH TYPE II

CRASH DATE: FEBRUARY, 2011

LOCATION: NEW YORK

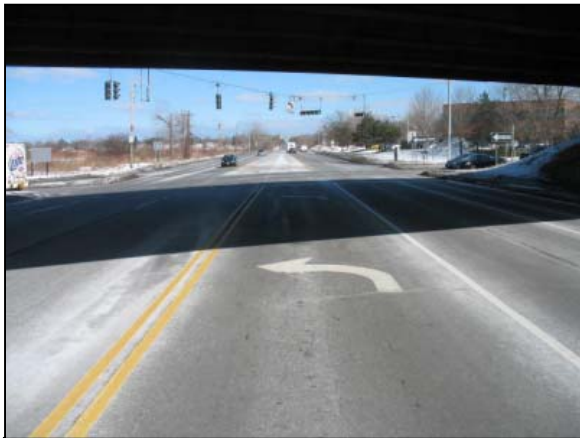
Figure 2: Northbound trajectory view of the ambulance.

The crash occurred at the four-leg intersection of a north/south road and a westbound entrance/exit ramp for a limited access highway. The intersection was controlled by overhead red/amber/green traffic signals. In the ambulance's northbound direction, the road was a six-lane undivided roadway that had three travel lanes in each direction. The right and center northbound lanes were for through-traffic passing through the intersection. The right northbound lane was designated for left-turn-only traffic entering the highway entrance ramp. In the Honda's southbound direction, the road consisted of a three-lane divided roadway with a 7.3 m (24 ft) wide painted center median. The left and center southbound lanes were for through-traffic and the right lane was a designated right-turn-only lane leading to the highway entrance ramp. The one-way westbound entrance ramp measured 6.8 m (22.3 ft) in width. A crescent-shaped gouge mark was identified on the entrance ramp and was attributed to the left front wheel rim of the ambulance. The gouge mark measured 2.1 m (6.9 ft) in length and denoted the post-impact movement of the ambulance. The speed limit in the area of the crash was 72 km/h (45 mph). **Figure 2** is a northbound trajectory view of the ambulance. **Figure 3** is a southbound trajectory view of the Honda.

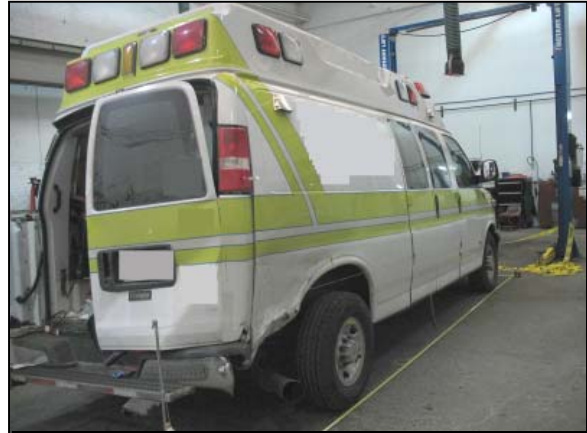
Figure 6: Right rear oblique view of the Chevrolet van-based ambulance.

The 2007 Chevrolet 3500 Express van was identified by the Vehicle Identification Number (VIN): 1GBHG396771xxxxxx and was manufactured as an incomplete vehicle in June 2007. **Figure 6** is a right rear oblique view of the vehicle. The van was designated as Model: CG33705 and was designed with a 395 cm (155 in) wheelbase. The powertrain consisted of a 6.6-liter, V8 diesel engine linked to a 4-speed automatic transmission with overdrive. The brake system consisted of a front and rear disc system with 4-wheel ABS. The Gross Vehicle Weight Rating was 4,355 kg (9,600 lb) with a front/rear axle split of 2,087 kg (4,600 lb) and 2,760 kg (6,084 lb), respectively. The vehicle was equipped with four Cooper Discovery LT245/75R16 tires. The size of the tires matched the manufacturer's recommendation. The specific tire data measured during the SCI inspection was as follows:

Tire	Measured Pressure	Measured Tread Depth	Restricted	Damage
LF	Flat tire	8 mm (10/32 in)	No	None, tire debaded
LR	532 kPa (77 PSI)	6 mm (8/32 in)	No	None
RR	463 kPa (67 PSI)	6 mm (8/32 in)	No	None
RF	387 kPa (56 PSI)	12 mm (15/32 in)	No	13 cm (5 in) section of wheel rim deformed

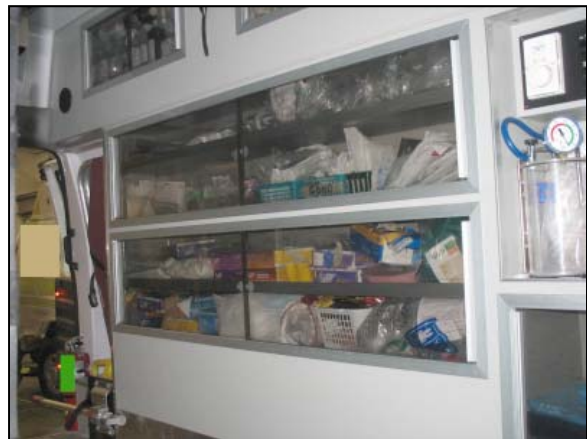
Figure 11: Interior view of the left wall in an exemplar ambulance.

The left wall consisted of three upper cabinets and a large four shelf unit at its center aspect. The upper cabinets measured 66 x 29 x 10 cm (26 x 11.5 x 4 in), length x height x depth. The four shelf unit measured 146 x 100 x 29 cm (57.5 x 39.3 x 11.4 in) in overall dimensions and was enclosed by two sets of sliding doors. The contents, sliding doors, and trim pieces of the rear upper cabinet and the four shelf unit were displaced throughout the interior and onto the patient and EMT during the crash. **Figure 10** is a view of the left interior wall of the crashed ambulance. **Figure 11** is a similar left interior view taken of an exemplar ambulance.

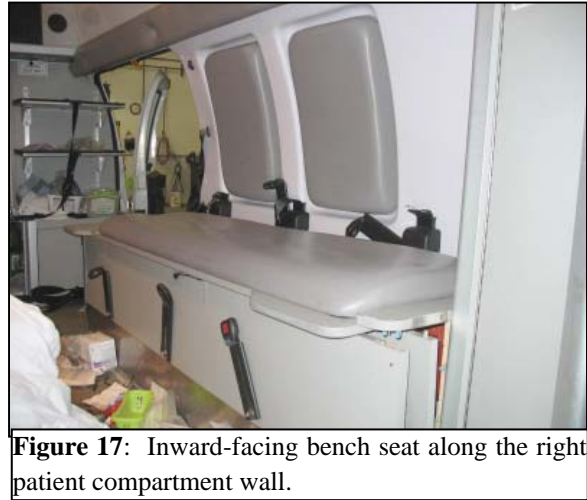
Figure 17: Inward-facing bench seat along the right patient compartment wall.

The EMT was seated on the forward aspect of the inward facing bench attending to the patient (**Figure 17**). Reportedly, he was recording the patient's vital signs. The EMT responded to the force of the impact by initiating a right lateral trajectory. The EMT was displaced into, and loaded, the right wall of the patient compartment. The subsequent CW rotation of the vehicle displaced the EMT into the right rear corner area of the compartment. The EMT remained in contact with the right corner and rode down the force of the crash.

During the crash event, the cot became displaced and engaged the lower extremities of the EMT. The EMT's contact with the cot resulted in an unknown lower extremity injury. As the vehicle came to rest, the EMT moved from the right rear corner area to the rear-facing attendant's seat based on a review of the Drive Cam video. The EMT then turned and began to assess the patient. He attended to the patient until the arrival of the first responders. The EMT was able to exit the ambulance unassisted and was ambulatory at the scene. He was transported to a regional trauma center, treated and released with a reported unknown lower extremity injury.

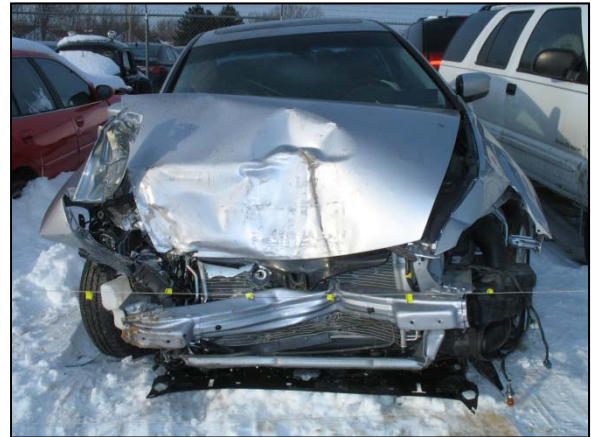
Figure 18: Front view of the Honda Accord.

The 2003 Honda Accord 2-door coupe (**Figure 18**) was equipped with EX level trim and was identified by the VIN: 1HGCM82663Axxxxxx. The date of manufacturer was March 2003. The digital odometer reading was unknown due to electrical system damage. The powertrain consisted of a 3.0-liter, 6-cylinder engine linked to a 5-speed automatic transmission with front wheel drive. The Honda was equipped with a 4-wheel ABS, disc brake system. The Honda's OEM 7-spoke alloy wheels were equipped with Bridgestone Turanza EL 41, P205/60R16 tires. The vehicle manufacturer recommended front and rear cold tire inflation pressure was 221 kPa (32 PSI) and 210 kPa (30 PSI), respectively. The specific tire data measured at the time of the SCI inspection was as follows:

Tire	Measured Pressure	Tread Depth	Restricted	Damage
LF	193 kPa (28 PSI)	6 mm (8/32 in)	No	None
LR	145 kPa (21 PSI)	6 mm (7/32 in)	No	None
RR	186 kPa (27 PSI)	6 mm (8/32 in)	No	None
RF	Flat tire	6 mm (7/32 in)	Yes	Cut in tire tread
